Manhole Inspection Summary

Manhole # S41I__056MH

Insp Date: **5/14/08 2:46 PM**

Location Address: **254 s exeter st**

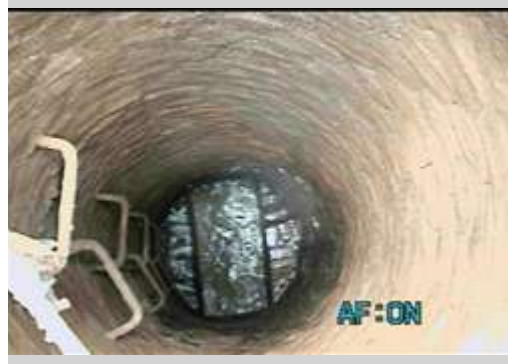
Top View

top view & steps

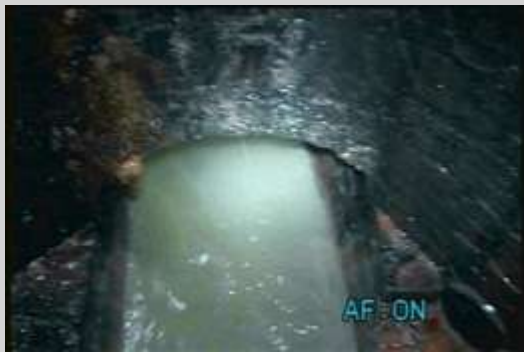
12 O'Clock Outflow

27 in. Circular Gravity Sewer
Pipe Out @ 12 O'Clock

Pipe Material: **Clay** ☐ Pipe Lined

Invert Depth: **19.17** (ft.) Flow Characteristics: **Fast**

Deposits: ☒ None ☐ Mud ☐ Sludge ☐ Debris ☐ Grease

Infiltration: **None** Pipe Seal Cond: **Unknown**

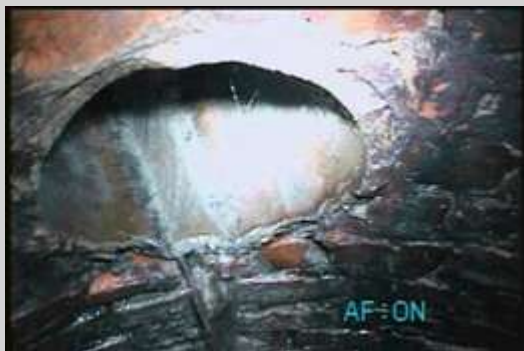
3 O'Clock Inflow

8 in. Circular Gravity Sewer
Pipe In @ 3 O'Clock

Pipe Material: **Clay** ☐ Pipe Lined

Invert Depth: **11.06** (ft.) Flow Characteristics: **Fast**

Deposits: ☒ None ☐ Mud ☐ Sludge ☐ Debris ☐ Grease

Infiltration: **None** Pipe Seal Cond: **Unknown**

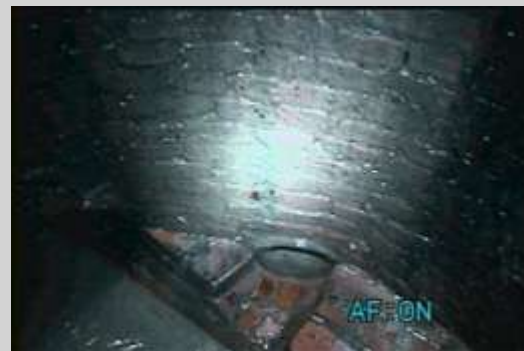
Drop In @ 3 O'Clock

couldnt extend camera anymore to get better pic

Drop: **Outside Direct**

Inv Depth: **19.07** (ft.)

Drop Condition: **Open**

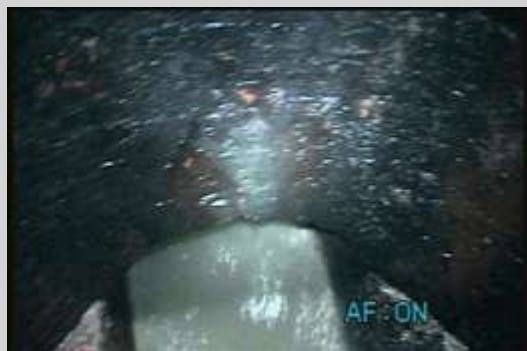
6 O'Clock Inflow

27 in. Circular Gravity Sewer
Pipe In @ 6 O'Clock

Pipe Material: **Clay** ☐ Pipe Lined

Invert Depth: **19.06** (ft.) Flow Characteristics: **Fast**

Deposits: ☒ None ☐ Mud ☐ Sludge ☐ Debris ☐ Grease

Infiltration: **None** Pipe Seal Cond: **Unknown**
